C. The Pedestrian Environment and Regional Commercial Centers

The Pedestrian Environment: Rating the Commercial Centers

Regional Commercial Centers: North Sub-region

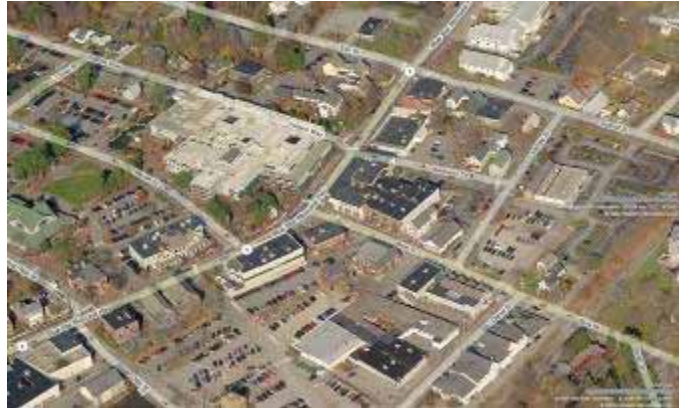
Freeport Village Center

*Rating: **Very Good***

Freeport Village has a good sidewalk network and well-marked crosswalks. It also has a high degree of pedestrian-oriented design with good quality streetscapes and higher quality urban design considerations such as buildings fronting streets and quality architecture.

Recent initiatives: Village Planning Committee Report (2003) which recommends new mixed use village commercial and high density residential zones.

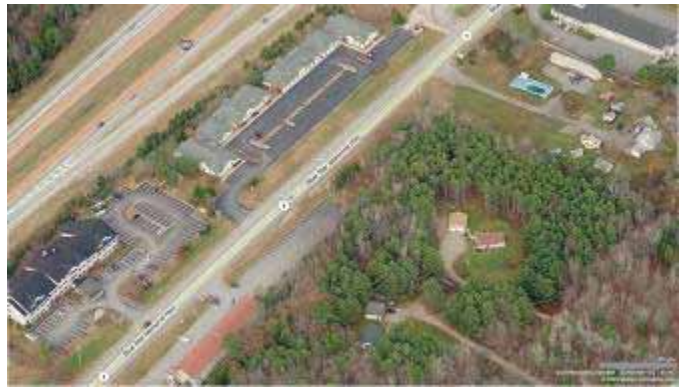
South Freeport, Route 1

*Rating: **Poor***

South Freeport/Route 1 is a strip highway commercial zone that is highly automobile-oriented characterized by large building setbacks and lot frontages dominated by parking lots. It has little to no accommodation for pedestrians.

Recent initiatives: Vision Plan for Route One South.

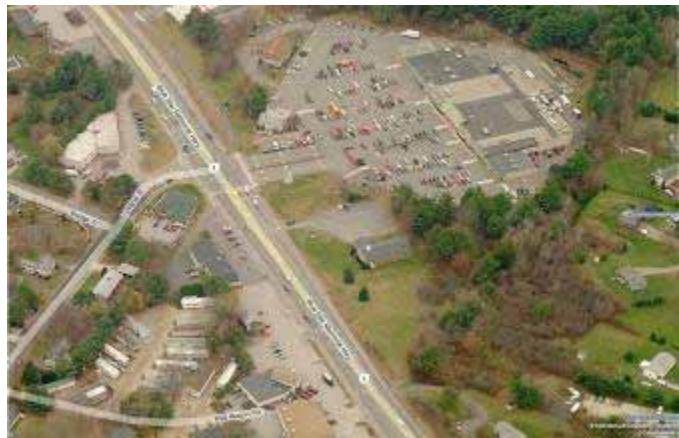
*Rating: **Poor***

Yarmouth, Route 1 North of the village center is a strip highway commercial zone that is highly automobile-oriented characterized by intermittent pedestrian accommodations with large building setbacks and parking lots dominating the road frontage. The Beth Condon Pathway terminates at the southern end of this center.

Recent initiatives: Route 1 Phase I (2005) & II (2009) Studies have been completed to improve access management, improve traffic flow and safety using multiple roundabouts, and improve pedestrian access along Route 1, including the extension of the pathway. Phase III is funded for 2009. A plan for future extension of the Beth Condon Pathway to Freeport has also been completed.

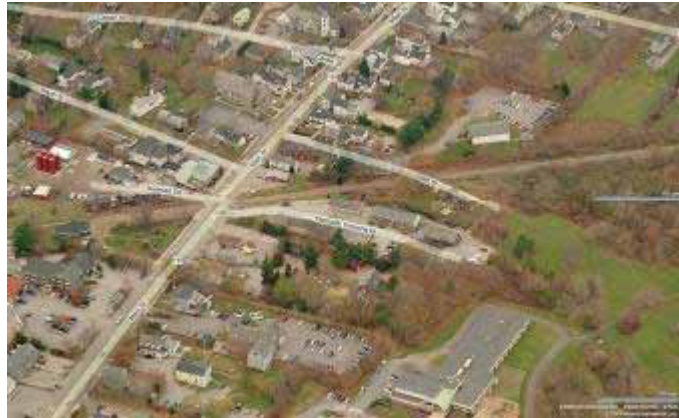
Yarmouth Village Center

Rating: **Good (-)**

Yarmouth Village has good, continuous pedestrian facilities and generally good urban design characteristics. Recent strip-style commercial development in a portion of the village center negatively impacts the generally positive pedestrian environment.

Recent initiatives: Beginning the exploration of form-based codes for the village (2009).

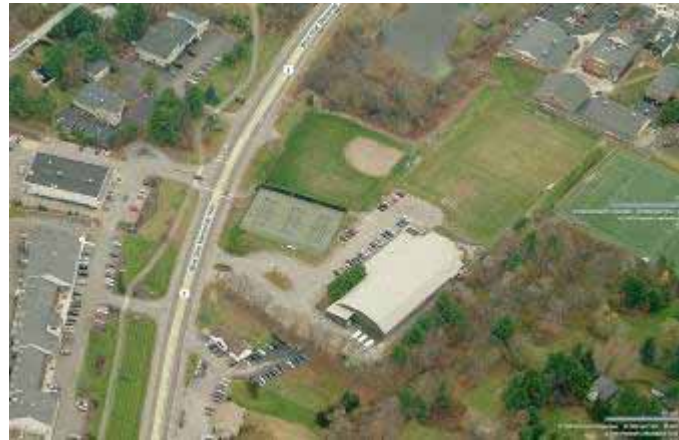
Yarmouth, Route 1 South

Rating: **Poor (+)**

Yarmouth, Route 1 South, like the North, is a strip highway commercial zone that is highly automobile-oriented with large building setbacks and parking lots dominating road frontage. The Beth Condon Pathway provides a quality, continuous pedestrian and bicycle connection along Route 1 in this section.

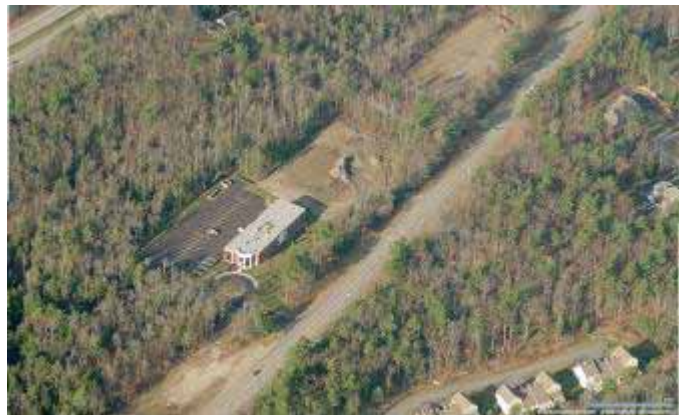
No. Falmouth/So. Cumberland, Route 1

Rating: **Poor**

The northern portion of Falmouth Route 1 and southern Route 1 in Cumberland is an evolving regional commercial center with primarily office and retail uses that is developing in a strip, highway commercial fashion.

Recent initiatives: Adoption of *Route 1 Design Guidelines* in Cumberland.

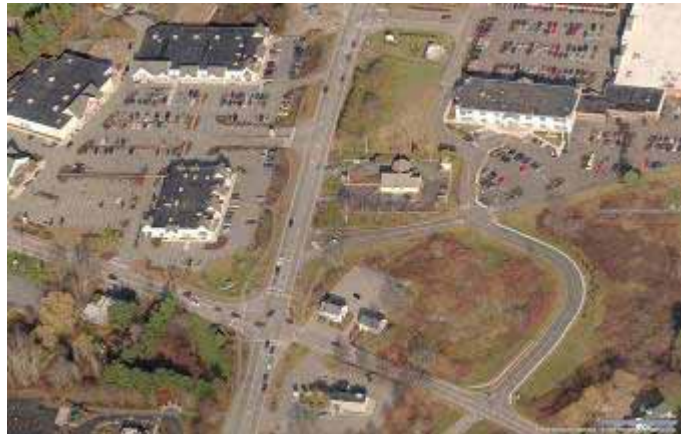
Falmouth Village Center, Route 1

Rating: Fair (+)

Falmouth, Route 1 is a much more visually attractive strip, highway commercial center than is typical. It has a much higher quality of pedestrian connections along portions of Route 1 and within parking lots. The overall orientation of the development within the center, though, still makes it highly automobile-oriented.

Recent initiatives: The town is currently reassessing redevelopment options at the Shaw's Plaza.

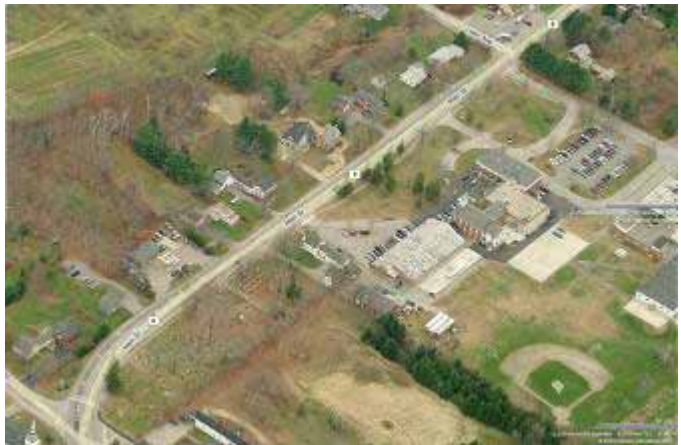
Rating: Good (-)

Cumberland Center is a small, primarily residential village center that is slowly adding commercial uses and has the opportunity to continue as a pedestrian oriented center. Some recent commercial uses have developed in an auto-oriented fashion.

Recent initiatives: Completion of a *Pedestrian Access Study* (2006).

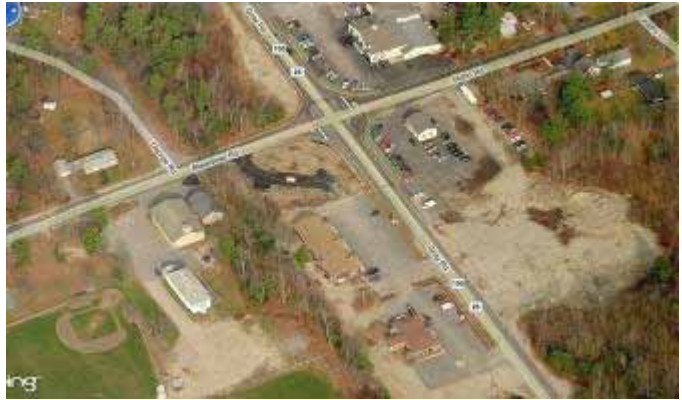
West Cumberland, Route 26/100

Rating: **Poor (+)**

West Cumberland is evolving in a strip highway commercial/automobile oriented fashion that will include pedestrian facilities and landscaping along Route 26/100. Buildings have large setbacks oriented to parking lots.

Recent initiatives: Route 100 Design Guidelines seek to improve the visual quality of development and provide some level of pedestrian facilities.

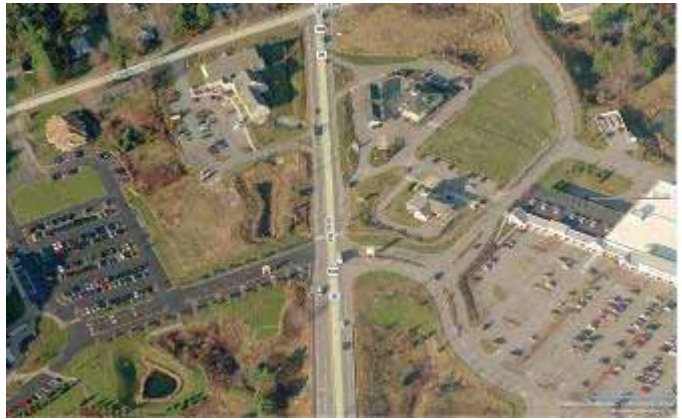
West Falmouth, Route 26/100

Rating: **Poor (+)**

West Falmouth is a strip, highway commercial center located at Maine Turnpike Exit 53 at Route 100/26. The center has a large shopping center, major banking back office operations center as well as smaller medical and child care services. It is highly automobile access oriented.

Recent initiatives: Exit 10 Design Guidelines.

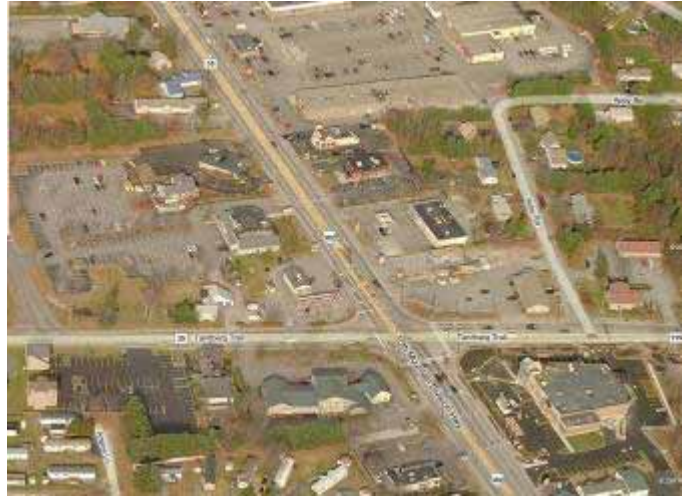
North Windham, Route 302

Rating: Poor (+)

North Windham is a large, sprawling highway commercial regional center along Route 302 at the gateway to the Lakes Region of Cumberland County. It has a number of large shopping centers and many single-story, single-use buildings abutting the roadway. The center is highly auto-access oriented. Portions of Route 302 have sidewalks along it.

Recent initiatives: No. Windham/Route 302 Traffic Study (underway, 2009).

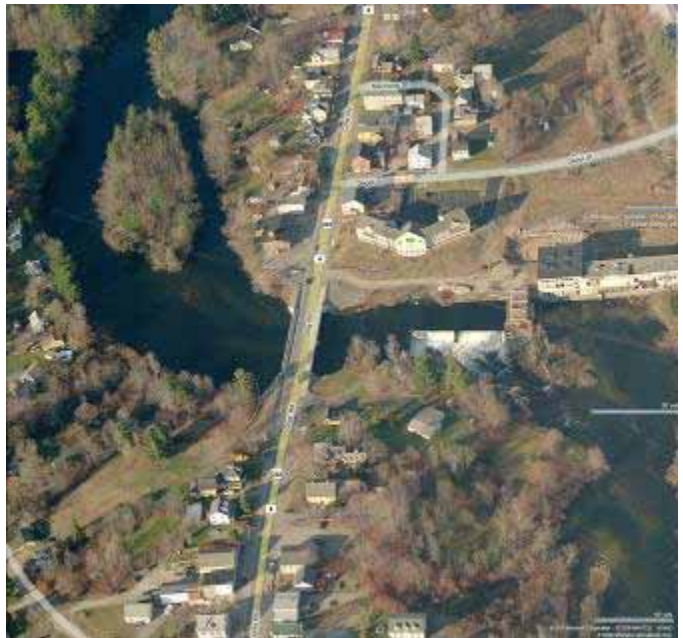
Little Falls, Gorham / South Windham, Windham

Rating: Good (-)

Little Falls/South Windham is a small village center on the Presumpscot River between Sebago Lake and downtown Westbrook. The center abuts the Mountain Division rail line and rail-trail. Most buildings are oriented to the street. Some pedestrian facilities rate closer to Fair than Good.

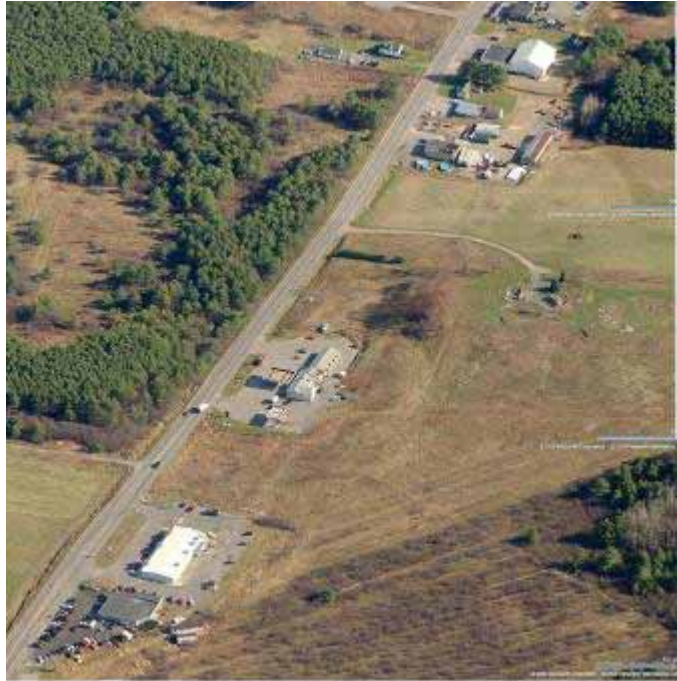
Moshers Corner, Gorham

Rating: **Poor**

Moshers Corner is a highway strip, automobile-oriented center along Route 25 between Gorham Village and downtown Westbrook at Route 237. There are little to no pedestrian facilities along Route 25. Buildings have large setbacks and are oriented to parking lots.

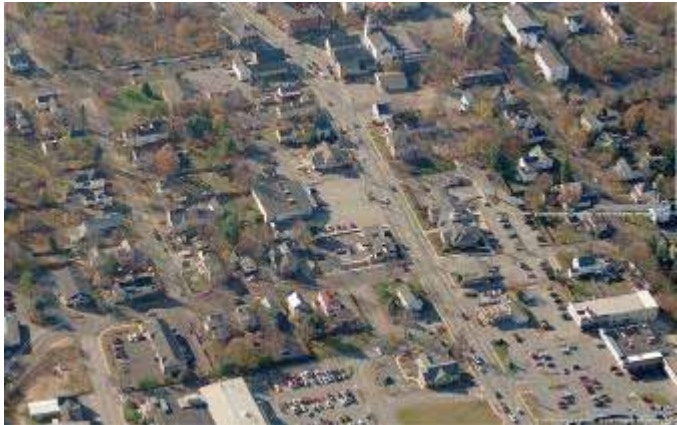
Gorham Village, Gorham

Rating: **Good (-)**

Gorham Village is centered upon Routes 25 and 114. A good portion of the historic structures remain which help create a quality streetscape. Quality sidewalks along Route 25 have been built in conjunction with recent road improvements. Several contemporary automobile-oriented shopping center developments near the intersection with New Portland Road have degraded the village center's pedestrian quality and orientation.

Recent initiatives: The Route 112 bypass was completed in 2009 and has reduced automobile and truck traffic from the 25/114 intersection. Several Village Master Plans have been completed and portions implemented.

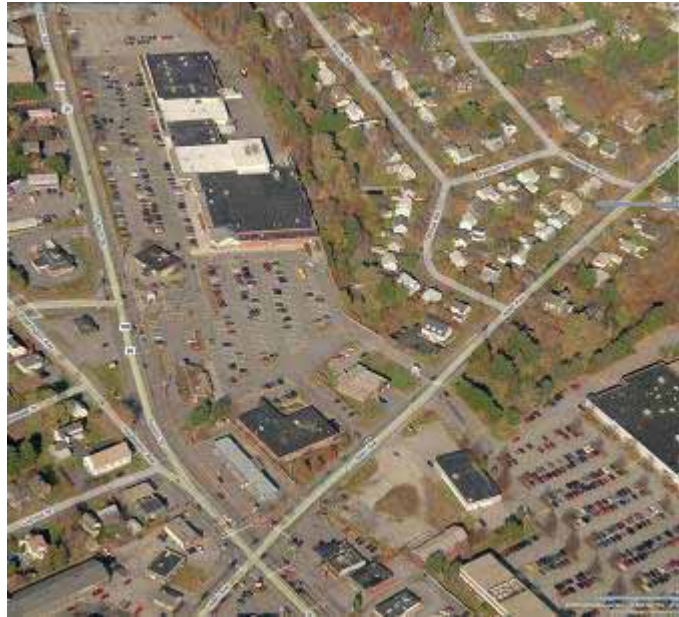
Allen's Corner/Northgate, Portland

Rating: Fair (-)

Allen's Corner/Northgate is located around the intersections of Routes 26 and 100. It is highly auto-access oriented with strip commercial style development. Buildings have large setbacks and are oriented to parking lots. There are gaps in the sidewalk network along streets. Allen's Corner is a very large intersection that has audible pedestrian signals to assist the blind/visually impaired. Few recent buildings are oriented to the street; most others are not.

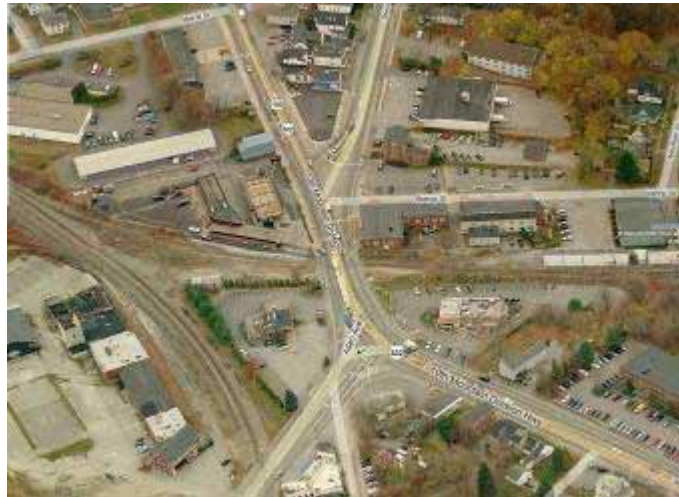
Morrill's Corner, Portland

Rating: Fair (-)

Morrill's Corner, centered on Route 302, is one of the most heavily traveled crossroads in the state with multiple intersections in close proximity to each other. Several historic buildings remain that establish a strong relationship to the street but the vast majority of contemporary development has strongly degraded the pedestrian environment, having poor urban design characteristics. The streetscape quality is generally poor.

Recent initiatives: Striping and signing of on-road bike facilities through Morrill's Corner in the Fall 2009. This will connect the existing bike lanes on outer Forest Ave to the downtown. PACTS funding for a corridor redevelopment/transportation study along Forest Avenue has been secured for fiscal year 2010.

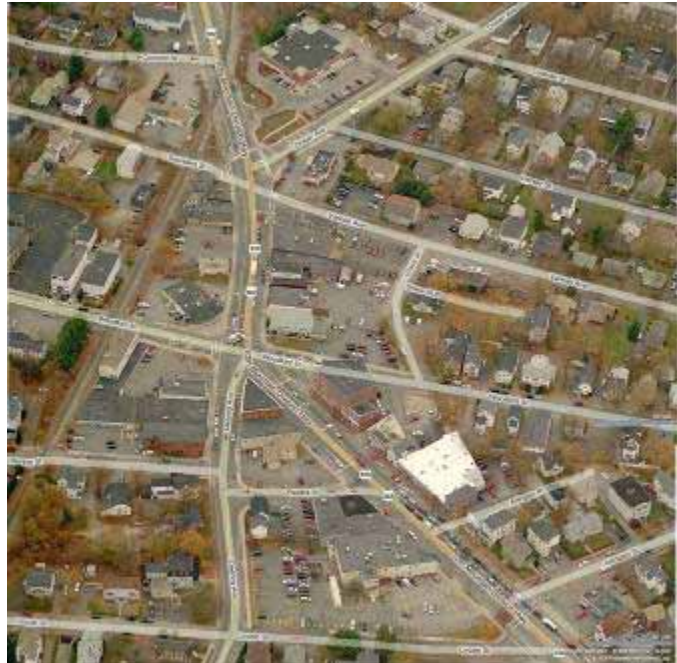
Woodfords Corner/Forest Avenue, Portland

Rating: **Good (-)**

Woodfords Corner is a busy crossroads on Route 302 midway between Morrill's Corner and the downtown. Smaller scale businesses are in buildings primarily oriented to street. Contemporary development has degraded the urban design quality of the center with single-story, single use design and building orientation to parking lots, not streets.

Recent initiatives: PACTS funding for a corridor redevelopment/ transportation study along Forest Avenue has been secured for fiscal year 2010.

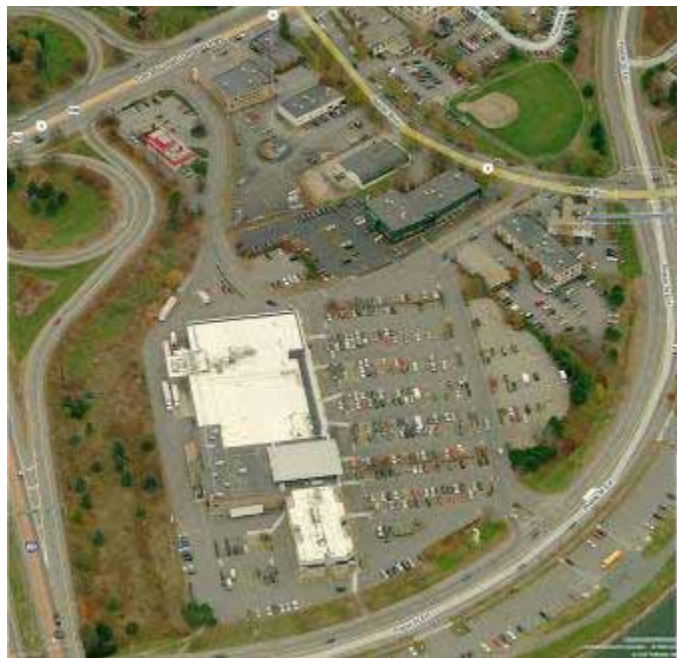
Back Cove Shopping Plaza, Portland

Rating: **Fair (-)**

Back Cove center is dominated by a large suburban style shopping center bounded by the Preble Street Extension, Baxter Boulevard, I-295 and Forest Avenue. Sidewalks are provided along street frontages. Buildings are oriented to parking lots. The proximity to USM and the Back Cove Trail provides an opportunity for more pedestrian activity.

Recent initiatives: PACTS funding for a corridor redevelopment/ transportation study along Forest Avenue has been secured for fiscal year 2010.

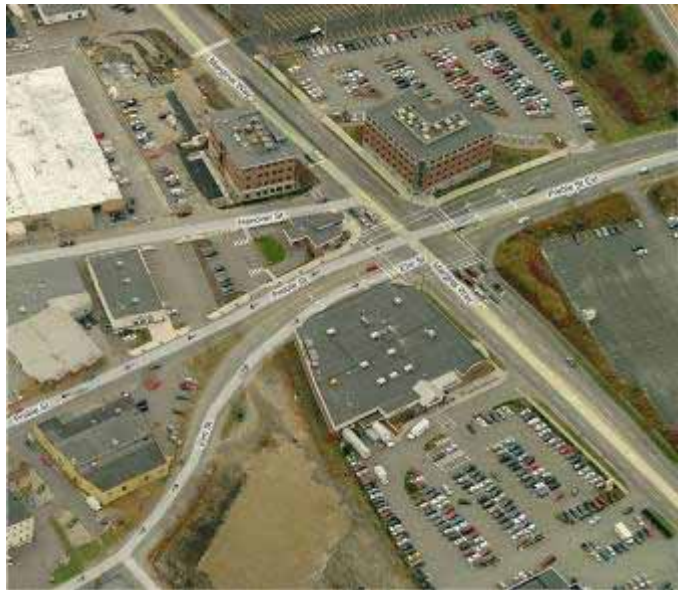
Bayside, Portland

Rating: Fair (+)

Bayside is a redeveloping, up and coming mixed use area on the Portland peninsula bounded by the Franklin Arterial, Forest Avenue and Cumberland Avenue. The commercial portion of Bayside is centered on Marginal Way. The most recent infill buildings are multiple stories, oriented to the street, and create a very high quality streetscape. Numerous sidewalk gaps remain and street crossings are difficult in many areas.

Recent initiatives: *A New Vision for Bayside (2000)* and subsequent implementation call for Bayside to emerge as a Transit Oriented

Development area. Forest Avenue and the Franklin Arterial are undergoing roadway redesign and redevelopment planning. The Bayside Trail (Phase 1 under construction in 2009) will provide a high quality pedestrian and bicycle connection through the redevelopment area linking Deering Oaks Park with the Eastern Promenade Trail.

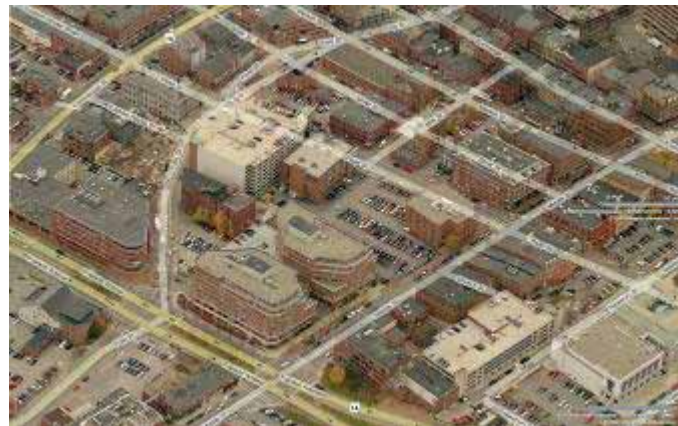
Downtown Portland, Portland, Maine

Rating: Very Good

Downtown Portland is Maine's largest urban downtown center. Overall, it is characterized by its highly developed sidewalk network and streetscapes, pedestrian-scaled development, and buildings predominantly oriented to streets. Some items detract from the quality of the pedestrian environment and include: numerous large surface parking lots devoid of landscaping along their street frontage that also create large gaps

in the building 'street wall'; several arterial roadways that have poor pedestrian design and orientation; and, spot locations with poor ADA accessibility. New pedestrian wayfinding signage has been recently installed (2009).

Recent initiatives: Peninsula Transit Study (2008), Franklin Street Arterial Redesign Study (2009), Eastern Waterfront Design Guidelines (2002), Portland Peninsula ADA Access Gaps (2008) and Wayfinding System Study (2008).

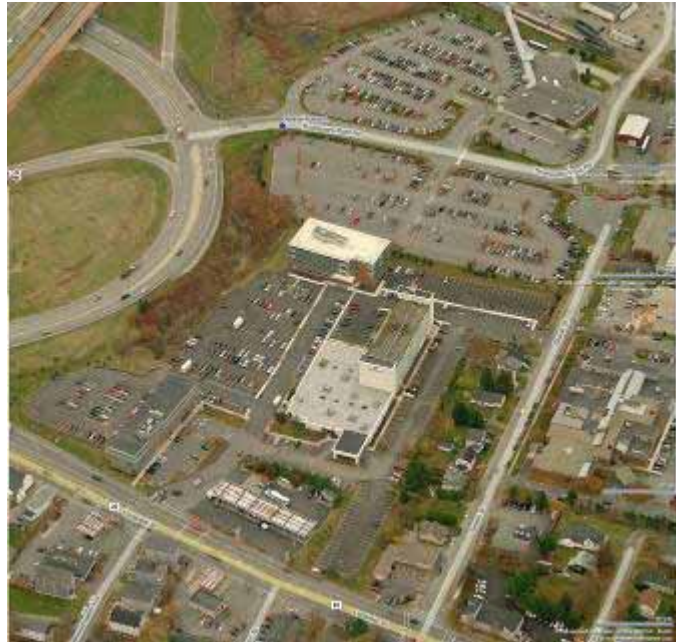
Libbytown, Portland

Rating: **Fair**

Libbytown is a neighborhood on the western edge of the Portland peninsula centered on Congress Streets and Park Avenue, including St. John Street/Union Station Plaza area, the Portland Sports Complex to Deering Oaks Park and extending to Sewall Street. It includes the Portland Transportation Center where the *Downeaster* Amtrak service and Concord Trailways bus service share an auto-access oriented facility. The Greyhound bus station is located at St. John Street and Congress Street. Roadway expansions and neglect of the streetscape over recent decades have resulted in a generally fair to poor pedestrian environment.

Recent initiatives: Connecting Libbytown: Pedestrian and Bicycle Improvements for a Dynamic Neighborhood (2009) prescribes a short and long term strategy for pedestrian and bicycle improvements to re-knit together much of this currently fragmented neighborhood and commercial center.

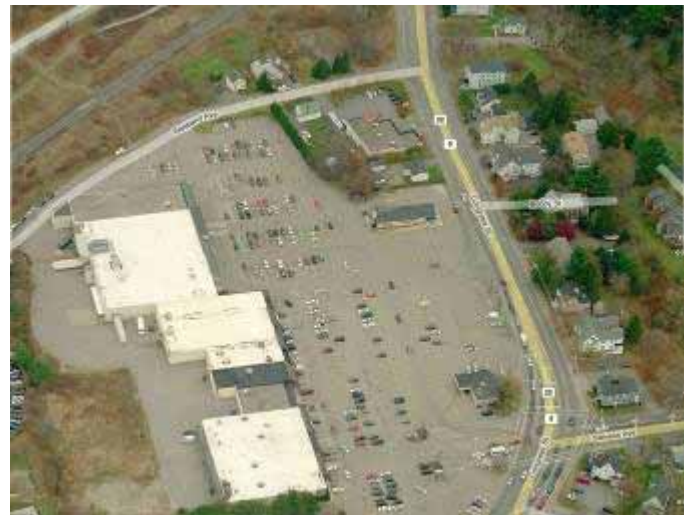
Westgate, Portland

Rating: **Fair**

Westgate is a neighborhood commercial center along Congress Street at Stevens Avenue. The Westgate Shopping Center, a strip commercial shopping plaza set back far from the street, dominates the area. Residential structures converted to commercial uses on the north side maintain the future opportunity for a quality streetscape. Additional 'Pad' buildings within the shopping center along Congress could re-create a stronger street edge on the south side.

Recent initiatives: Outer Congress Street Traffic Study (2007).

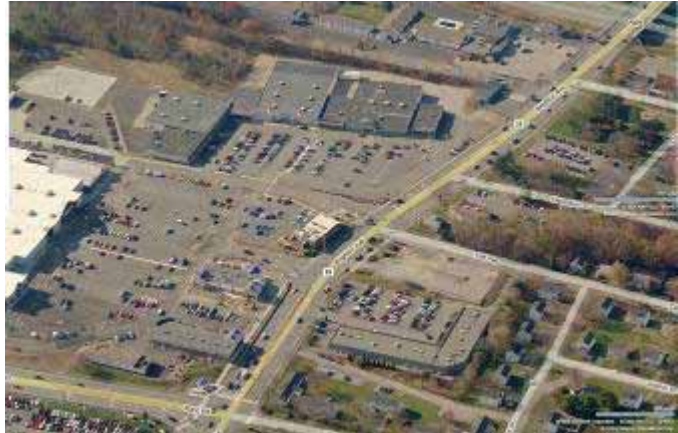
Route 25 'Gateway'/'Pine Tree Shopping Center, Portland and Westbrook

Rating: Poor (+)

This large, sprawling regional commercial center is oriented around Route 25, Riverside Street and Larrabee Road in Portland and Westbrook. It contains several large suburban-style shopping centers and many single-story, single-use commercial buildings. Most all the buildings are oriented to parking lots and have large setbacks from the public street. Most streets have sidewalks on at least one side of the road, but streetscape quality is fair to poor and street crossings are difficult. Some recent buildings have begun to infill parking lots to establish better streetscape conditions.

Recent initiatives: The *Brighton Avenue Corridor Study* (late 1990s) sought to improve streetscape quality in conjunction with traffic improvements.

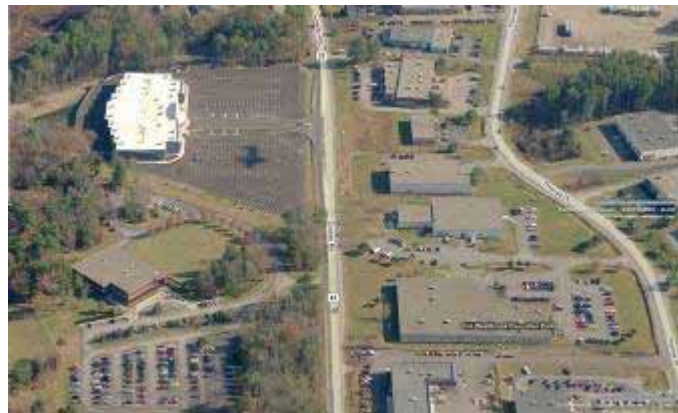
Spring/Cummings Road & County Road/Route 22, Westbrook

Rating: Poor

This commercial center contains an office/industrial park and numerous strip-highway style developments. Recent development, including a large cinema complex and roadway changes, have greatly increased the area's automobile orientation.

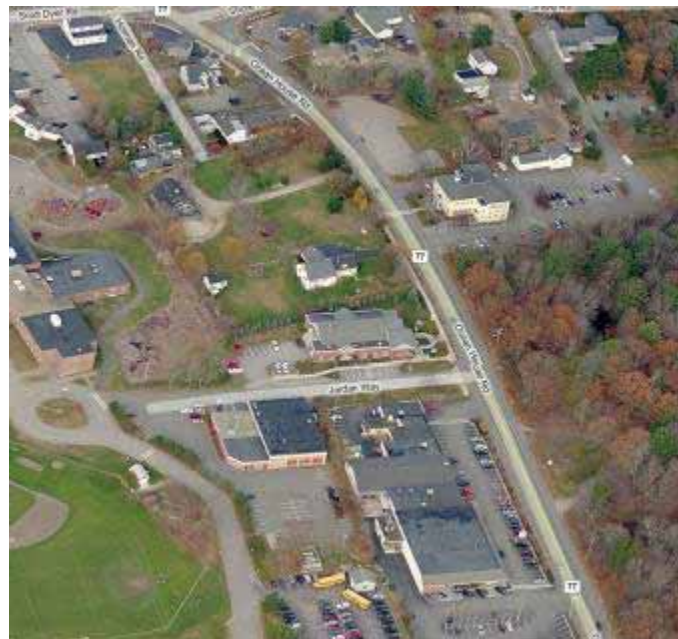
Cape Elizabeth Town Center, Cape Elizabeth

Rating: Fair (+)

Cape Elizabeth Town Center is a small commercial center with a good mix of civic, commercial and residential uses in close proximity. Until recently, contemporary development, including a strip shopping center, had eroded the pedestrian environment over time. The most recent development, as well as investment in pedestrian infrastructure including crosswalks and pedestrian signals, has begun to knit the town center together.

Recent initiatives: Town Center Pedestrian Safety Working Group (2009), Town Center Signalization Project (2008).

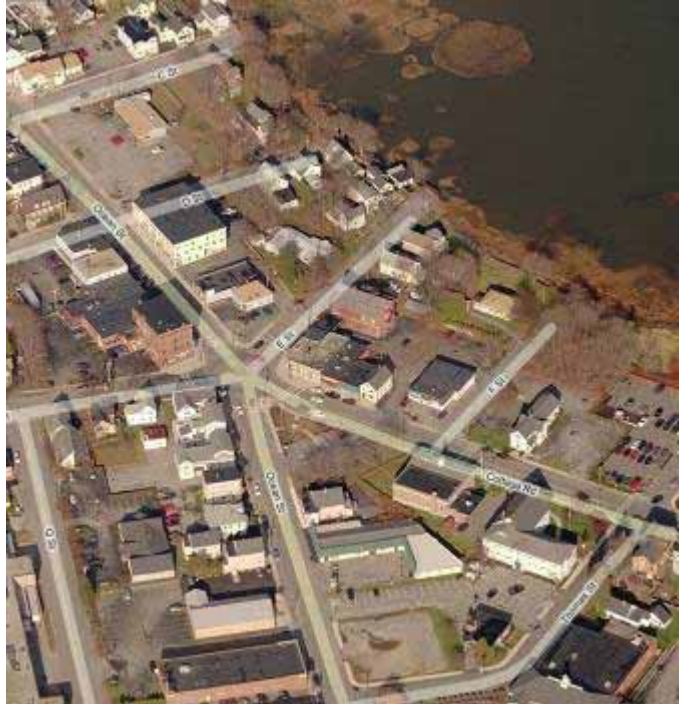
Knightsville, South Portland

Rating: **Good**

Knightsville is a small scale commercial center well integrated with a tightly knit residential neighborhood at the end of the peninsula extending into Portland Harbor. Until recently, development, while oriented to the street, was often single-story uses of lower architectural quality. Recent zoning changes to promote mixed use development allowed increased density, introduced minimum height requirements (24') and require higher quality design to enhance the pedestrian orientation and vitality of the area.

Recent initiatives: Relocation of Casco Bay Bridge (1990s), Knightsville Design District (1997, updated in 2001), Village Commercial Zone established (2004), Knightsville Millcreek Neighborhood Master Plan (2005).

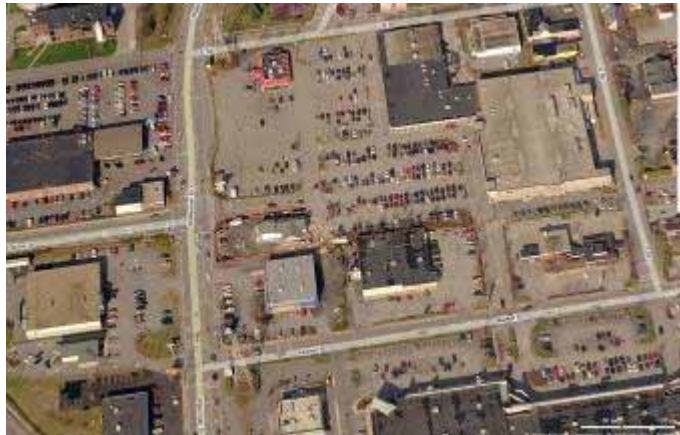
Millcreek, South Portland

Rating: **Fair**

Millcreek is a suburban style commercial district within an urban area next to Knightsville and is bounded by the Casco Bay Bridge and Broadway. It is dominated by the Millcreek Shopping Center and surrounded by a large number of single-story, single-use buildings with large setbacks that are oriented to parking lots. The South Portland Greenbelt runs along Millcreek's edge by Broadway.

Recent initiatives: Relocation of Casco Bay Bridge (1990s), Knightsville Millcreek Neighborhood Master Plan (2005).

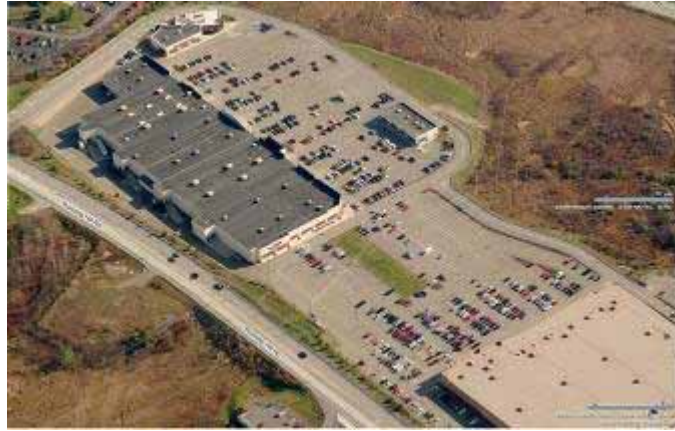
Maine Mall Area, South Portland

*Rating: **Poor (+)***

The Maine Mall area is one of the largest regional shopping areas in Northern New England. It is anchored by the Maine Mall but has numerous large strip shopping centers, big box retailers, and small to mid-size single-story, single-use buildings, as well as several large non-retail employers such as Fairchild Semiconductor, National Semiconductor and the Portland Newspapers. Most arterials have sidewalks along them but there are many gaps and street crossings are difficult in many locations. While some infill buildings have been built, most all buildings have large setbacks and are oriented to parking lots and driveways, not public streets. A trails group has planned an extensive trail network within the area to link this major retail and employment center to Portland and other portions of South Portland.

Most arterials have sidewalks along them but there are many gaps and street crossings are difficult in many locations. While some infill buildings have been built, most all buildings have large setbacks and are oriented to parking lots and driveways, not public streets. A trails group has planned an extensive trail network within the area to link this major retail and employment center to Portland and other portions of South Portland.

Recent initiatives: Maine Mall Area Pedestrian Master Plan (2001), West End Trails Committee Trails Master Plan (2008).

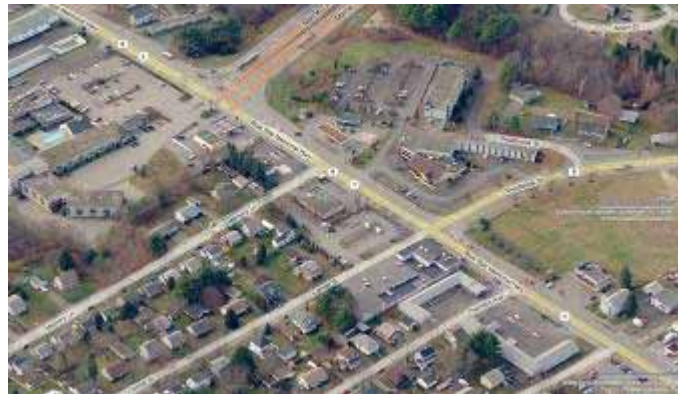
Main Street/Route 1, South Portland

*Rating: **Fair***

Main Street in South Portland has eroded into a strip highway commercial district with an automobile orientation. Sidewalks are provided along the roadway but the streetscape and visual quality are low. Moderate density neighborhoods abut the commercial center creating opportunity to rejuvenate the area.

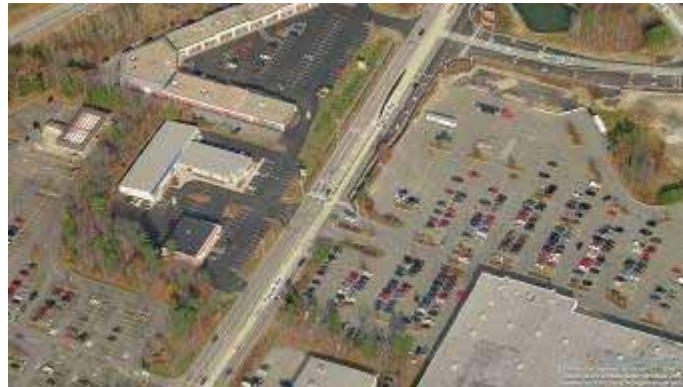
Payne Road, Scarborough

Rating: Poor

The Payne Road area is an extension of the Maine Mall area to the south. It has multiple large strip shopping centers and big box retail stores. It is highly automobile oriented with buildings set back from the street and oriented to large parking lots along the street. Sidewalks are present along short sections of roadway but many gaps remain and street crossings are difficult with little or no pedestrian signals at intersections. Pedestrian access from streets to businesses is generally poor.

Recent initiatives: Design Standards for Scarborough's Commercial Districts (2009).

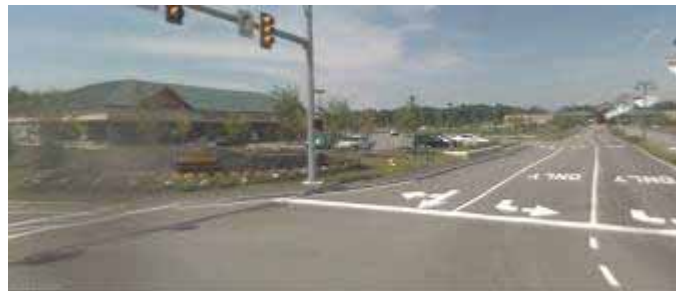
Haigis Parkway, Scarborough

Rating: Fair

Haigis Parkway is an emerging, planned low density commercial center with direct access to the Maine Turnpike. It is just beginning to build out with the first developments recently being completed. It is planned as an automobile-access oriented commercial center. Sidewalks and street crossings are being built along shopping center access roads.

Recent initiatives: Report of the Haigis Parkway Committee (2001), Design Standards for Scarborough's Commercial Districts (2009).

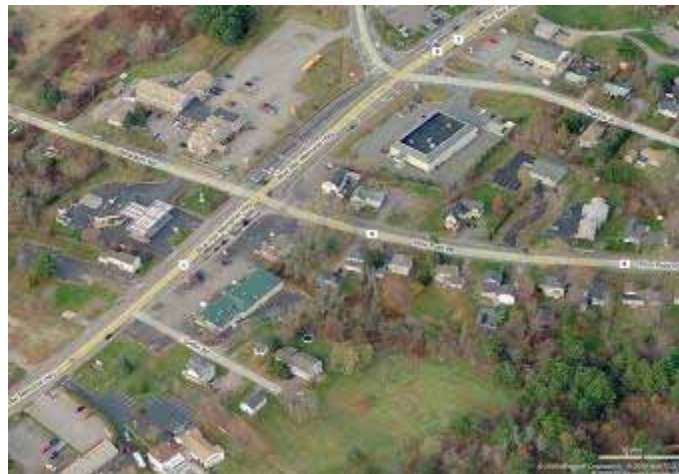
Dunstan Corner, Scarborough

Rating: Good (-)

Dunstan Corner is a small village center along the southerly portion of Route 1 near the Saco city line. The village has a small commercial center with abutting residential areas. The commercial center, which lines Route 1, has been eroded over time by strip style automobile oriented development. A recent project improved sidewalks and street crossings along much of Route 1 south of Pine Point

Road/Broadturn Road. North of Pine Point Road it remains Fair for pedestrians. The Dunstan Crossing mixed use project includes a compact mix of houses with a small retail/commercial center integrated with the development.

Recent initiatives: Dunstan Corner Sidewalk Improvements, Dunstan Crossing Neighborhood, Route 1/Payne Road Road Intersection Design, Comprehensive Plan Update (2006), Design Standards for Scarborough's Commercial Districts (2009).

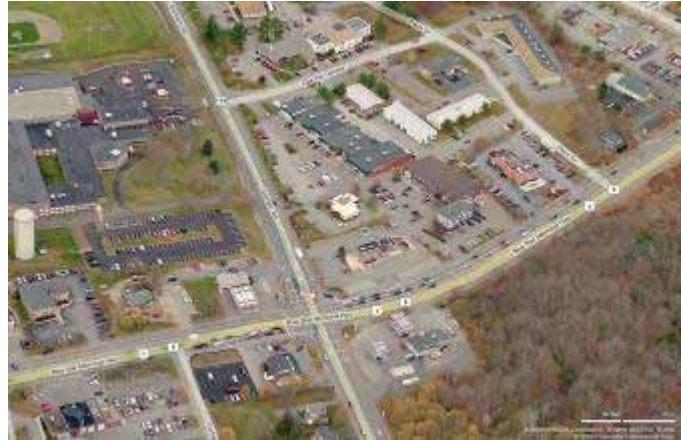
Oak Hill, Scarborough

Rating: Poor (+)

The Oak Hill area is one of Scarborough's largest commercial centers, focused on smaller and mid-size businesses. It is also home to its civic/municipal center as well. It encompasses the Route 1-Route 114/Route 209 intersection and surrounding area. It is comprised of several strip shopping centers and a large number of single-story, single-use buildings with large setbacks and buildings oriented to parking lots. Many street segments lack sidewalks and many street crossings are difficult for pedestrians. Recent changes to design standards require new buildings to be more oriented to the street and development of a more pedestrian scale streetscape. An area located north of Oak Hill has large-scale, automobile-oriented office, research and institutional uses.

Recent changes to design standards require new buildings to be more oriented to the street and development of a more pedestrian scale streetscape. An area located north of Oak Hill has large-scale, automobile-oriented office, research and institutional uses.

Recent initiatives: Comprehensive Plan Update (2006), Design Standards for Scarborough's Commercial Districts (2009).

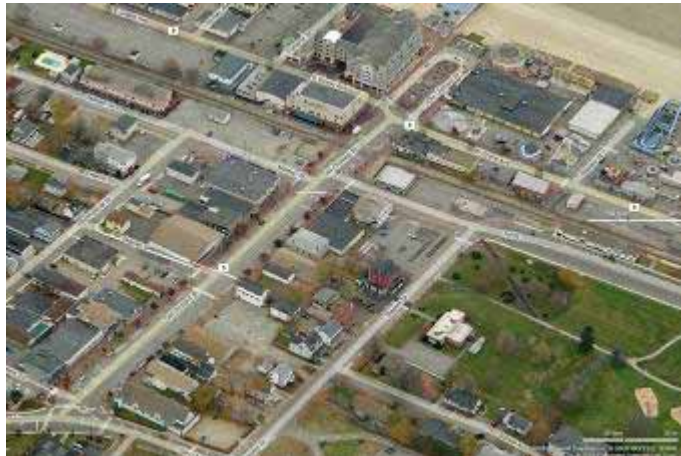
Downtown Old Orchard, Old Orchard Beach

Rating: Good (-)

Downtown Old Orchard Beach is traditional Maine summer beach destination that is reinventing itself as a year-round commercial and residential center. Most businesses and buildings are small to mid-size in scale and oriented to the street. Off-street parking lots have eroded the streetscape by creating expanses of parking between buildings and streets and numerous buildings have been replaced by surface parking lots.

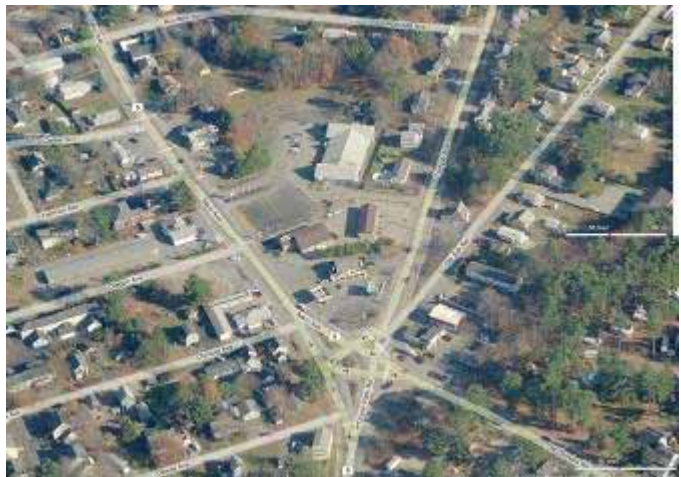
Halfway, Old Orchard Beach

Rating: Fair

The Half Way commercial center is a small gateway to the beach areas of Saco and Old Orchard Beach, located at the junction of Route 5/Ocean Park Road/Saco Avenue-Old Orchard Road-Temple Avenue. It is comprised of small retail businesses and lodging. While there are sidewalks located along major streets, the streetscape has been degraded by large curb cuts.

Recent initiatives: Halfway Roundabout Conceptual Design (2008).

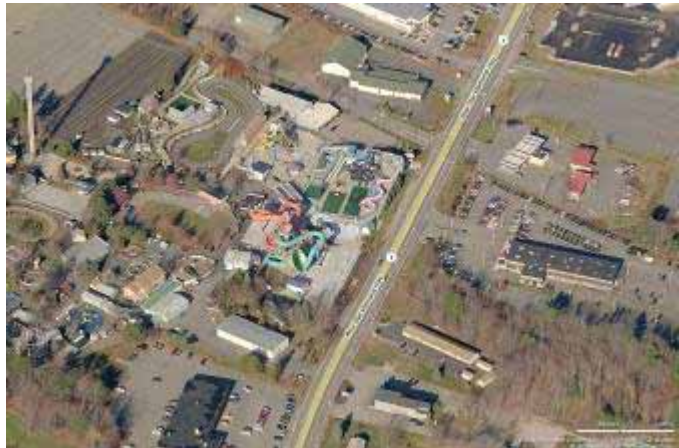
Funtown/Route 1, Saco

*Rating: **Poor***

The Funtown/Route 1 commercial center is a highly automobile oriented strip commercial area. It has two large recreational sites (Funtown & Splashtown) that are large summer seasonal destinations. Automobile dealerships also dominate the area. Existing sidewalks are very limited but new sidewalks are planned north of this center as part of new residential development near the Scarborough town line.

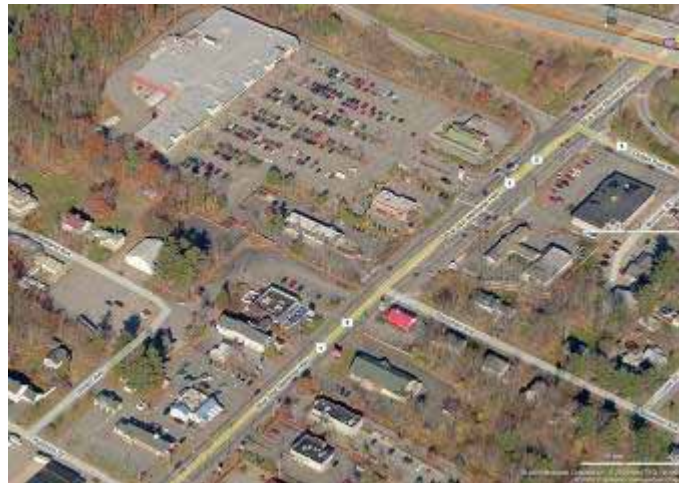
Route 1, Saco

*Rating: **Fair***

Route 1, just north of the downtown in Saco, is a highway strip commercial center. Most development is single-story, single use buildings set back from the street with parking or driving lanes between buildings and the street. Sidewalks and street crossings are located along Route 1. Access from Route 1 to building entrances is generally poor.

Recent initiatives: Route 1 Access Management Study.

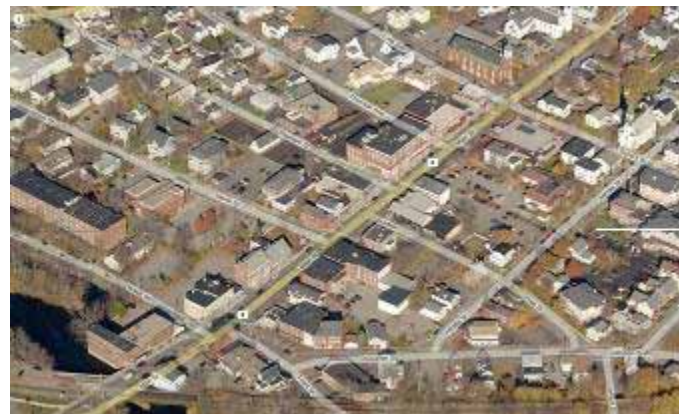
Downtown Saco, Saco

*Rating: **Very Good***

Downtown Saco, centered on Main Street, has a very high quality, attractive streetscape as well as high quality urban design characteristics. Sidewalks are generous in width and street crossings are well marked. Buildings are typically multi-story, multi-use and are sited at the back of the sidewalk creating a well-defined streetscape. Parking is located on-street and to the side and rear of buildings. A good mix of residential uses is located in close proximity to the downtown.

Recent initiatives: Downtown Sidewalk Improvements (2009).

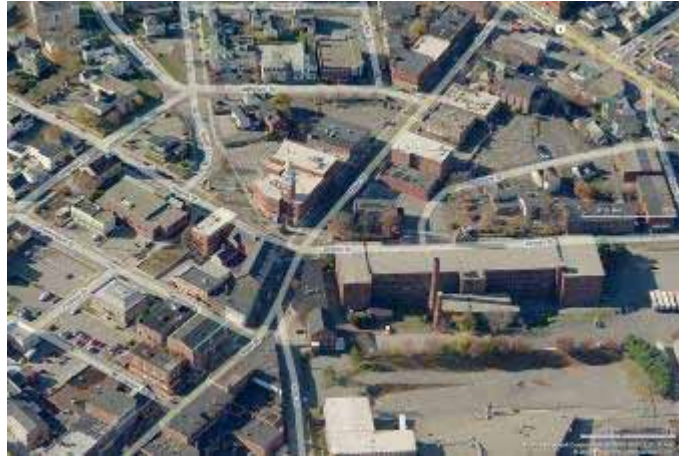
Downtown Biddeford, Biddeford

Rating: Good

Downtown Biddeford is an historic downtown that has good streetscape and urban design characteristics. Sidewalks are functional but in need of rehabilitation. Street crossings are well-spaced. Buildings are located well at the back of sidewalks but building facades have been degraded with contemporary retrofits over the last 30 years (a municipal program is available to restore these facades).

Recent initiatives: Mill District Master Plan (2008), Heart of Biddeford Main Street Program/Heart and Soul Project (On-going).

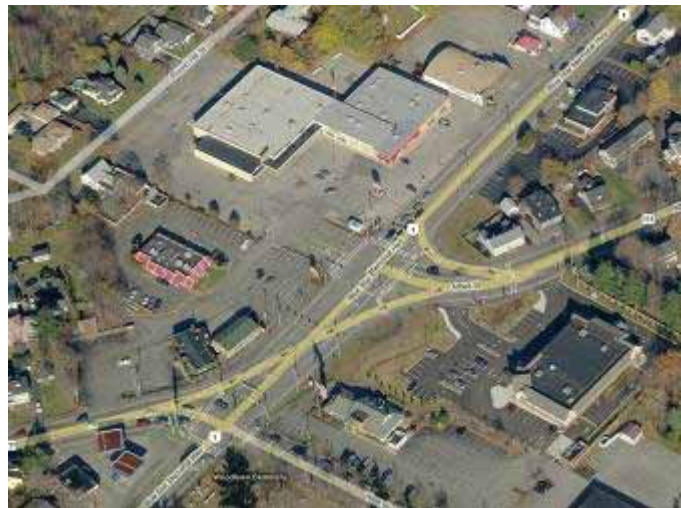
Five Corners, Biddeford

Rating: Fair

The Five Corners commercial center is located at the intersection of Routes 1 and 111. It has many single-story, single-use buildings primarily oriented to automobile access and parking lots. Sidewalks and street crossings along the arterials provide good connectivity.

Recent initiatives: Recent road and sidewalk project.

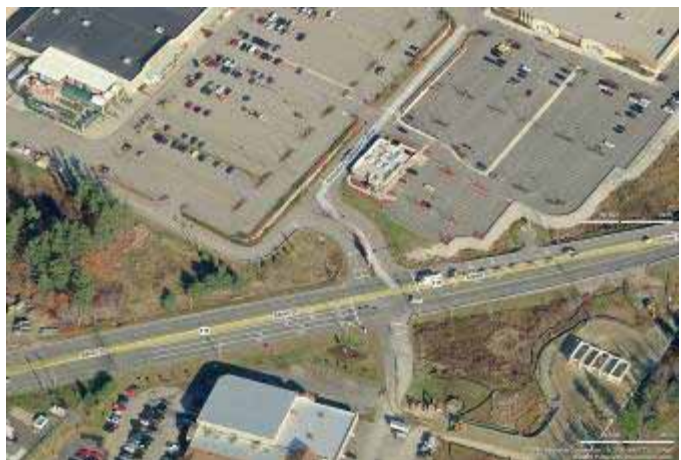
Biddeford Crossing/Route 111, Biddeford

Rating: Poor

Biddeford Crossing/Route 111 is a highly automobile oriented highway strip commercial area comprised of several large big box retail developments as well as smaller strip malls and single-story, single-use buildings stretching along Route 111 north and south of the Maine Turnpike Interchange. Pedestrian facilities along and across Route 111 are poor. Recent big box developments do provide for fair internal site pedestrian circulation.

Recent initiatives: The new Turnpike bridge did not include pedestrian facilities to access Biddeford Crossing.
